1198010003 - Madison County

Estate of Chemetco

FOS File

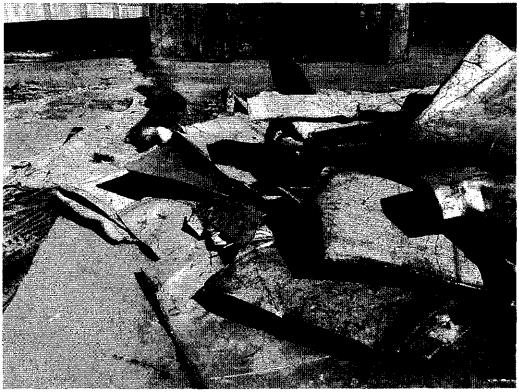
Stainless steel that was sent to a Chicago scrap dealer was returned because it had too much lead residue adhering to the surface. Mr. Garcia and Mr. Murray could not remember the name of the scrap dealer that rejected the scrap. The scrap rejected contained about 6% lead. The scrap company wants the stainless steel to contain 0% lead. Three companies have been on-site to demonstrate different cleaning techniques to remove the lead from the surface. Currently the only method that has worked is high pressure water and using a hand grinder to grind away the surface layer of the steel. On October 29, 2010 I returned to the site and spoke with Jorge Garcia. According to Mr. Garcia, the method that AIS wants to use to clean the steel is a combined high pressure water and sand mixture. He estimated that AIS will generate between 2 – 20 pounds of spent sand per minute or about 4.8 tons per day. I explained that the spent sand is a solid waste and at least a special waste. A representative sample would need to be collected of the spent sand and tested for TCLP metals. The sand will most likely be a hazardous waste.

Date: 10/14/2010
Time: 2:00 - 3:45
Direction: East
Photo by: Chris
Cahnovsky
Exposure #: 006
Comments: Stainless
steel rejected from
metals buyer due to
high lead content

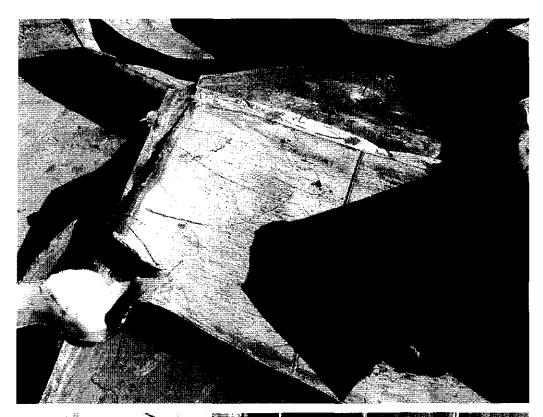
Date: 10/14/2010
Time: 2:00 - 3:45
Direction: East
Photo by: Chris
Cahnovsky
Exposure #: 007
Comments: Stainless
steel rejected from
metals buyer due to
high lead content

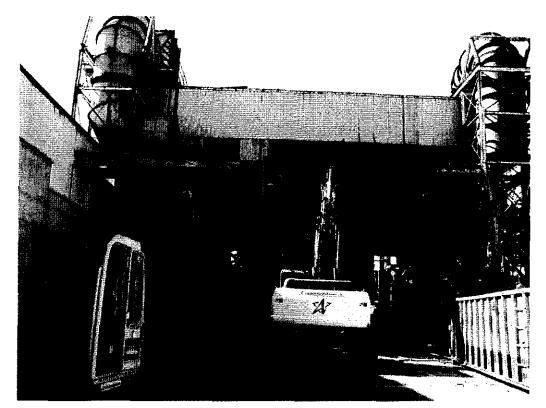
AIS has begun the demolition of the AAF area. Small sections of pipe are being crimped to prevent dust from dropping to the ground. The pipe is then emptied and the fines are taken to the Fines Building. The scrap is being cut into five foot sections to meet the scrappers specification. The stainless steel is being stockpiled prior to being moved to the Dome Building for decon. The other steel is being directly sent to Grossman Metals.

Date: 10/14/2010 Time: 2:00 - 3:45 Direction: West Photo by: Chris Cahnovsky Exposure #: 009 Comments: AAF Demolition

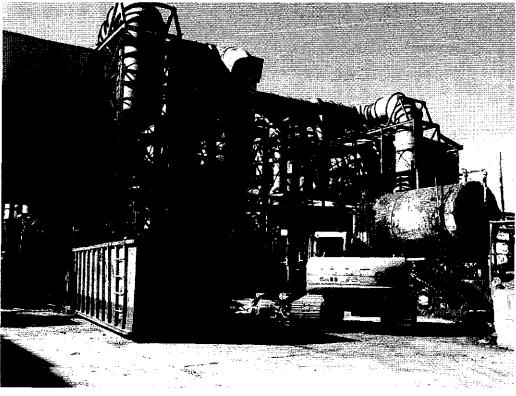
Photo by: Chris Cahnovsky Exposure #: 010 Comments: AAF Demolition

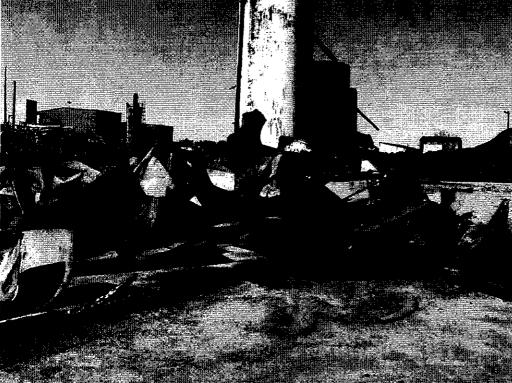
Photo by: Chris Cahnovsky Exposure #: 012 Comments: AAF Demolition

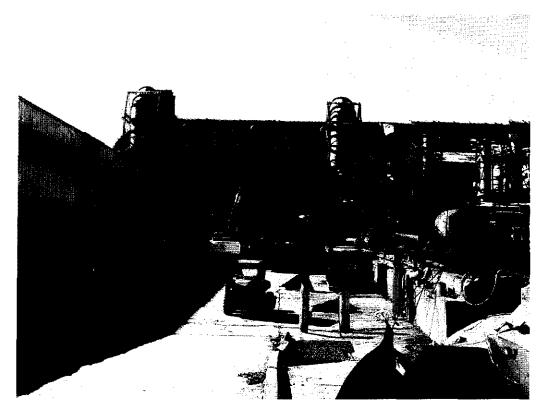
Date: 10/14/2010 Time: 2:00 - 3:45 Direction: West Photo by: Chris Cahnovsky Exposure #: 013 Comments: AAF Demolition
